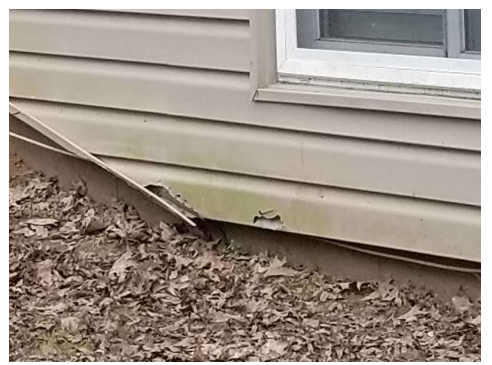
### 3.1.1 Siding, Flashing & Trim

## **CRACKING - MINOR**

Siding showed cracking in one or more places. This is a result of temperature changes, and typical as homes with stucco age. Recommend monitoring.

Recommendation  
Contact a qualified siding specialist.

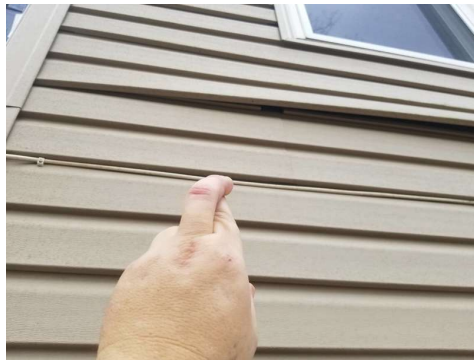
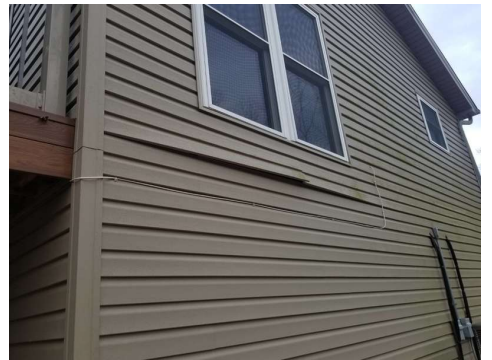
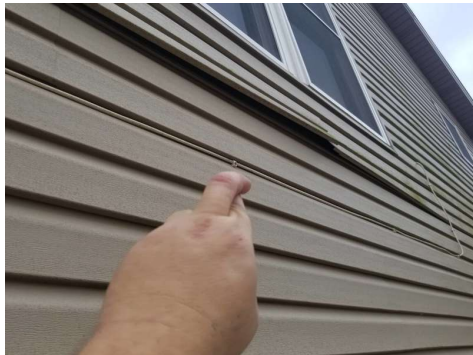
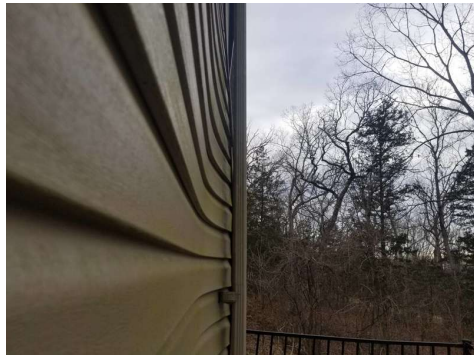
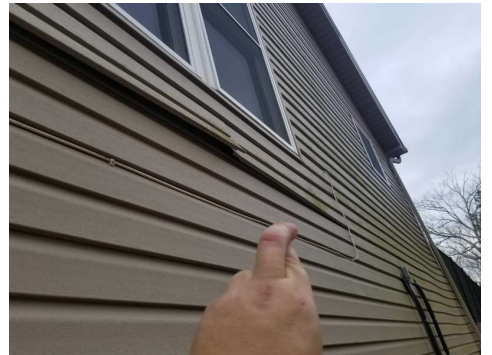
### 3.1.3 Siding, Flashing & Trim

#### **LOOSE SIDING**

NORTH

One or more siding boards were loose, which could result in moisture intrusion. Recommend a qualified siding contractor secure and fasten.

Recommendation  
Contact a qualified professional.

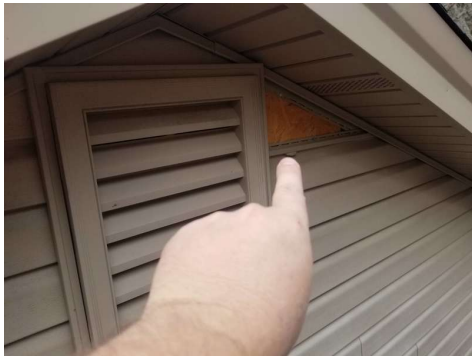
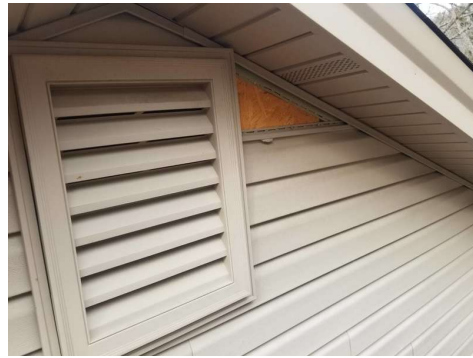
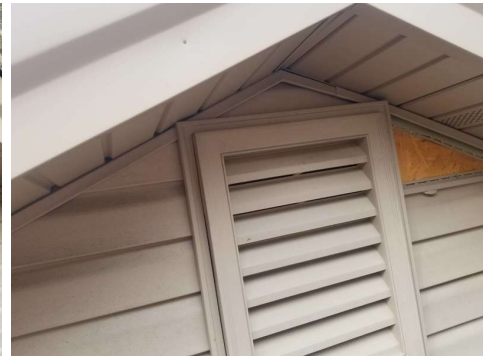
### 3.1.4 Siding, Flashing & Trim

#### **MISSING SIDING**

At time of inspection I observed to missing siding pieces. This is a minor defect as this will a loud water penetration.

Recommendation  
Contact a qualified professional.

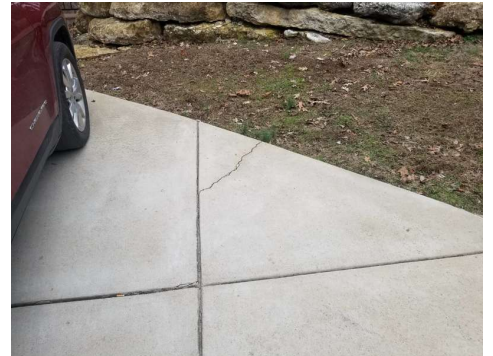
3.3.1 Walkways, Patios & Driveways

**DRIVEWAY CRACKING - MINOR**

Minor cosmetic cracks observed, which may indicate movement in the soil. Recommend monitor and/or have concrete contractor patch/seal.

Recommendation  
Contact a qualified concrete contractor.

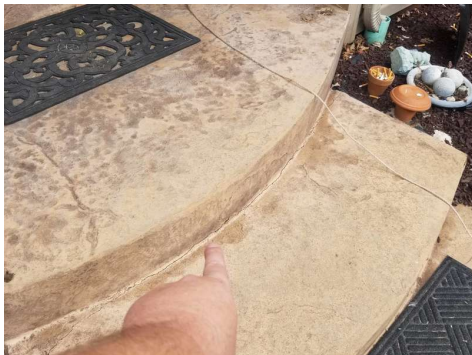
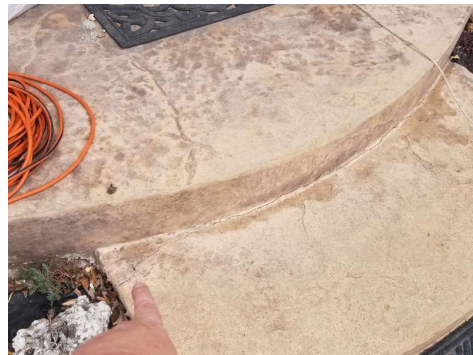
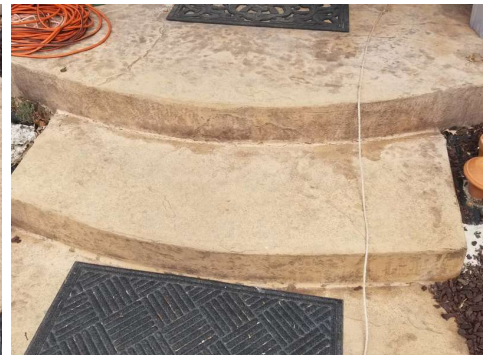
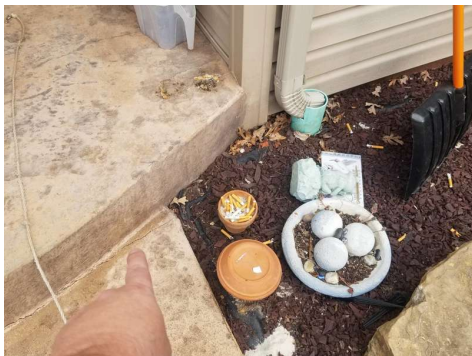
3.3.2 Walkways, Patios & Driveways

**WALKWAY CRACKING - MINOR**

Minor cosmetic cracks observed. Recommend monitor and/or patch/seal.

Recommendation  
Contact a qualified concrete contractor.

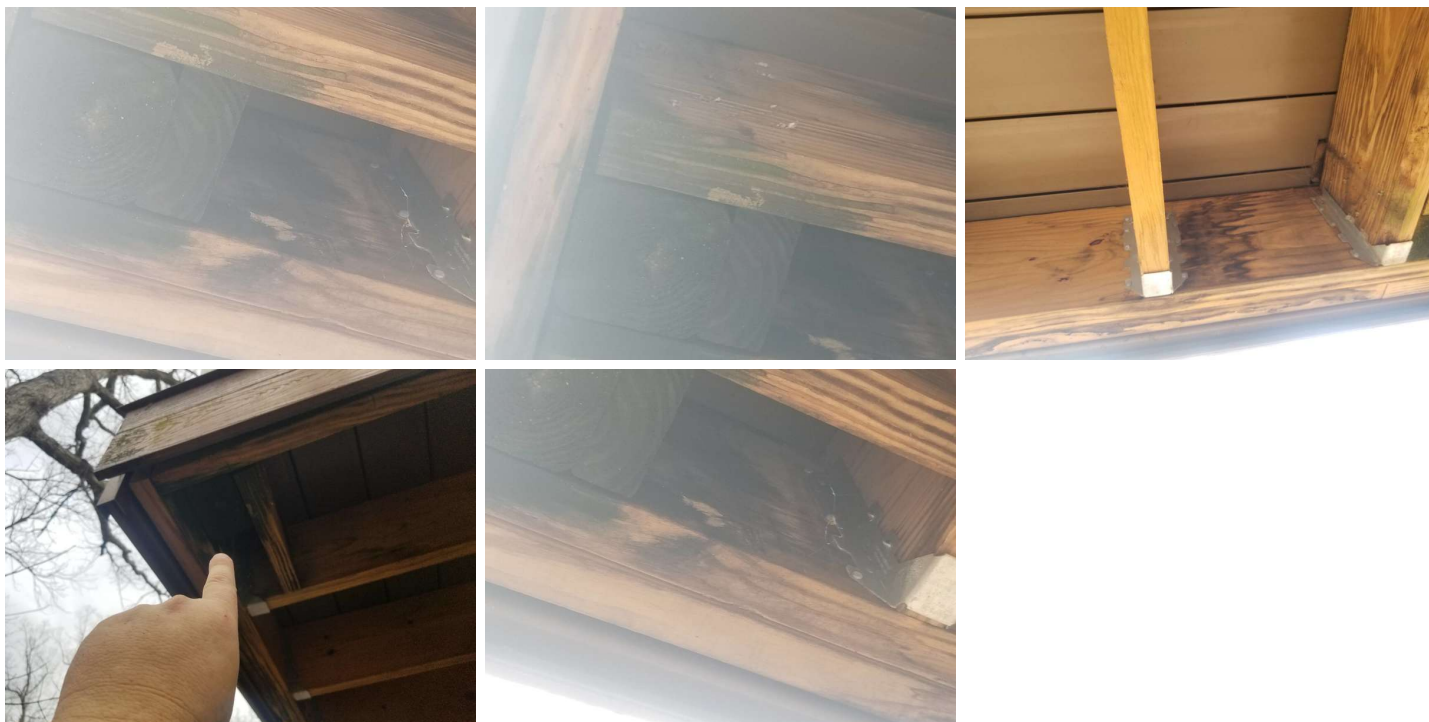
### DECK - WATER SEALANT REQUIRED

CORNER SUPPORT UNDERSIDE OF DECK

Deck is showing signs of weathering and/or water damage. Recommend water sealant/weatherproofing be applied.

Contact a qualified deck contractor.

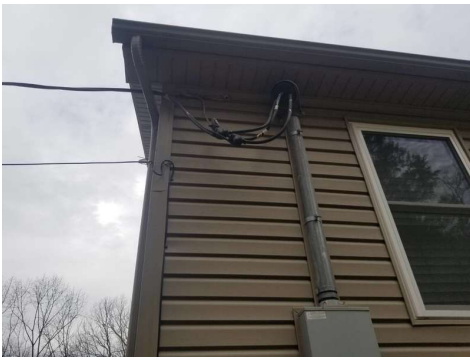
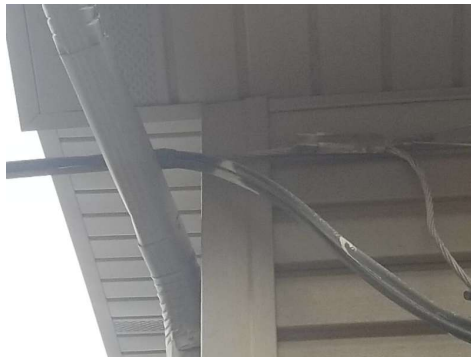
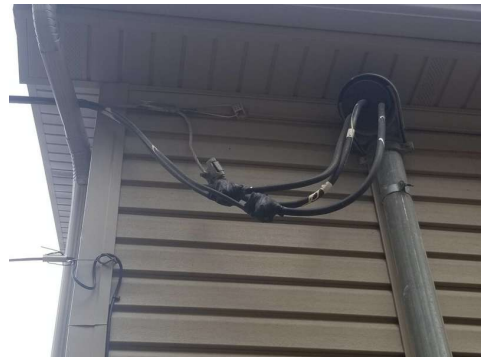
#### 8.1.1 Service Entrance Conductors

### **SERVICE WIRES TOUCHING DOWNSPOUT**

I observed Service entrance wire resting on downspout. This could lead to fraying the sheathing of the wires.

Contact a qualified professional.

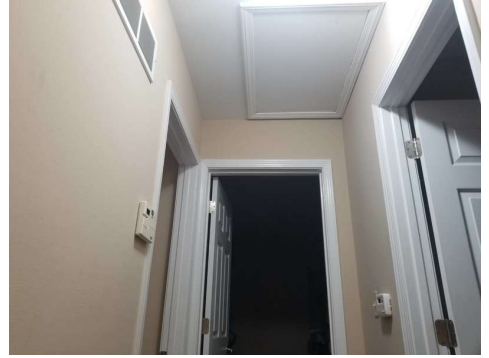
#### 8.6.1 Smoke Detectors

### **LOW BATTERY**

#### MASTER BEDROOM

Smoke detector failed to respond when tested. Recommend battery be replaced.

Recommended DIY Project

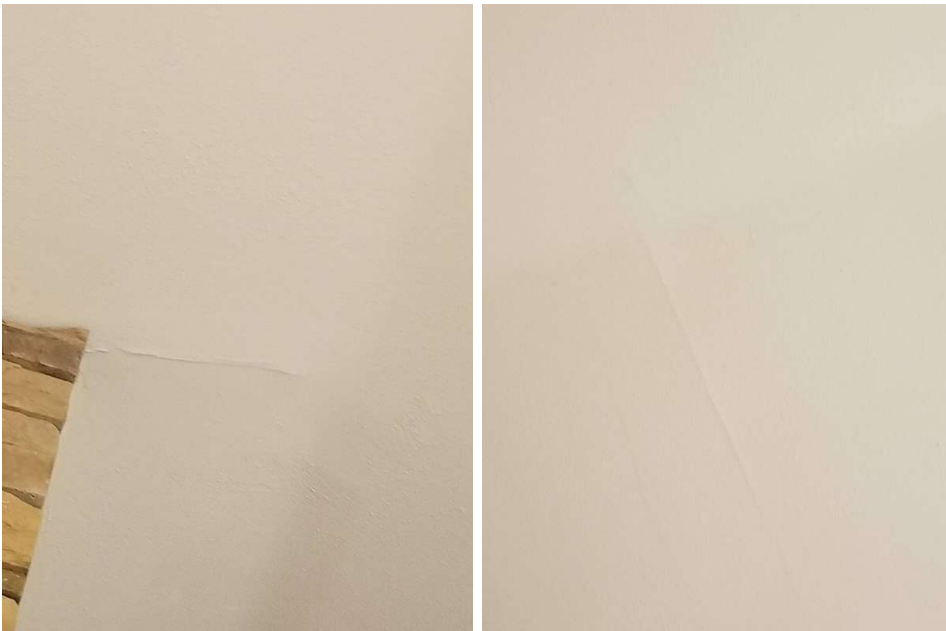
#### 11.5.1 Ceilings

### **MINOR DAMAGE**

#### LIVING ROOM

Minor damage or deterioration to the ceiling was visible at the time of the inspection.

Contact a qualified professional.

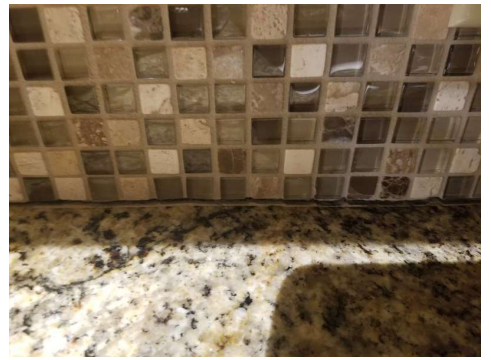
11.7.2 Countertops & Cabinets

**GROUT DETERIORATING**

KITCHEN

Grout lines were cracked or severely deteriorated. Recommend a qualified contractor repair or replace grout.

Recommendation  
Contact a qualified professional.
